Manhole Inspection Summary

Manhole # S21G__011MH

Insp Date: **4/6/09 10:25 AM**

Location Address: **114 VINE ST**

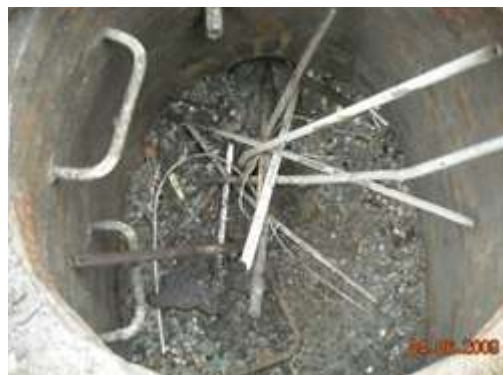
Top View

DEBRIS IN CHANNEL

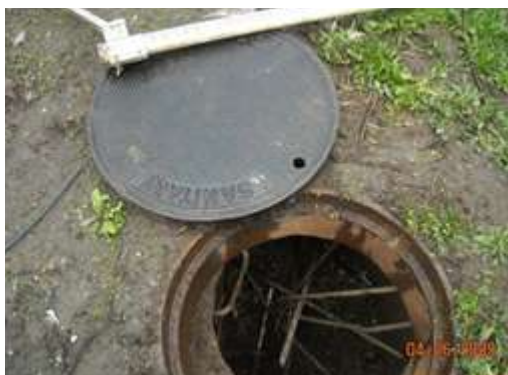
NEW LID

NEW 24" LID PREVIOUSLY REPLACED BY REI/DRAYCO

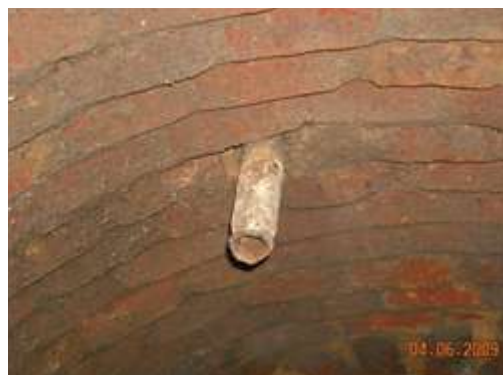
Defect 5

PIPE INTRUSION IN CORBEL WALL

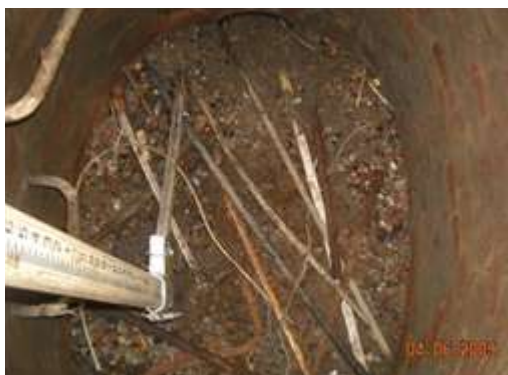
Defect 4

Condition: ☐ Sound ☐ Cracked ☐ Root Intrusion ☐ Deteriorated ☐ Leaks ☒ **Debris**

DEBRIS IN CHANNEL

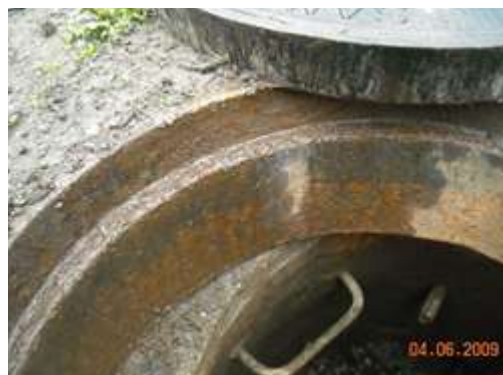
Defect 3

Subject To Ponding: **Sheeting**

EVIDENCE OF INFILTRATION DUE TO SHEETING/FRACTIONAL LEAKS

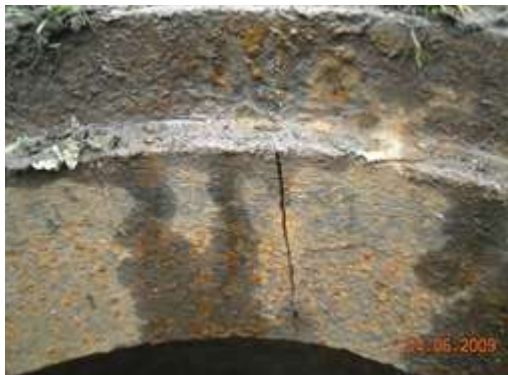
Defect 2

☒ **Cracked**

☒ **Leaks**

FRAME IS CRACKED

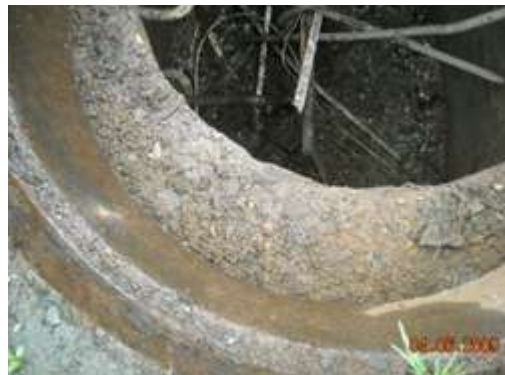
Defect 1

Frame Offset: **6** (in.)

FRAME OFFSET 6"
